PROJECT REPORT PROFILON® ER1

Government building, Oslo (N)

The Security Concept

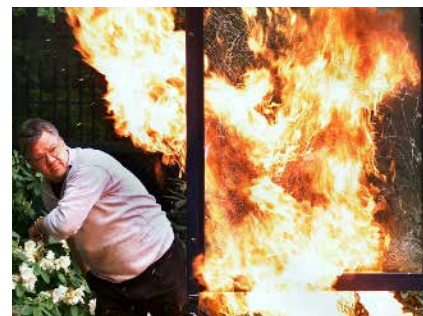
Execution of tests for security film PROFILON® ER1

PROFILON® ER1 security film is used worldwide in buildings with a very high risk of terrorist attacks. The bomb blast resistant properties have been tested in the recognized shocktube test.

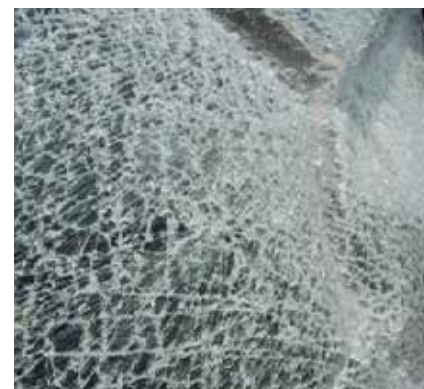
Destructions of glass in Oslo's centre after bomb explosion.

In the afternoon of 22nd July, 2011 Oslo's Government district was almost completely destroyed by a heavy explosion of a car bomb. Eight people lost their lives, ten were seriously injured. The explosion took place between the Oil- and Energy Ministry and a 17-storey high-rise, where several ministries and the office of Prime Minister Jens Stoltenberg are placed. The bomb based on 950 kilos ANFO exploded in a VW Crafter. In a 1 kilometer radius the pressure wave destroyed building façades. There were fragments in the streets all around where the attack took place.

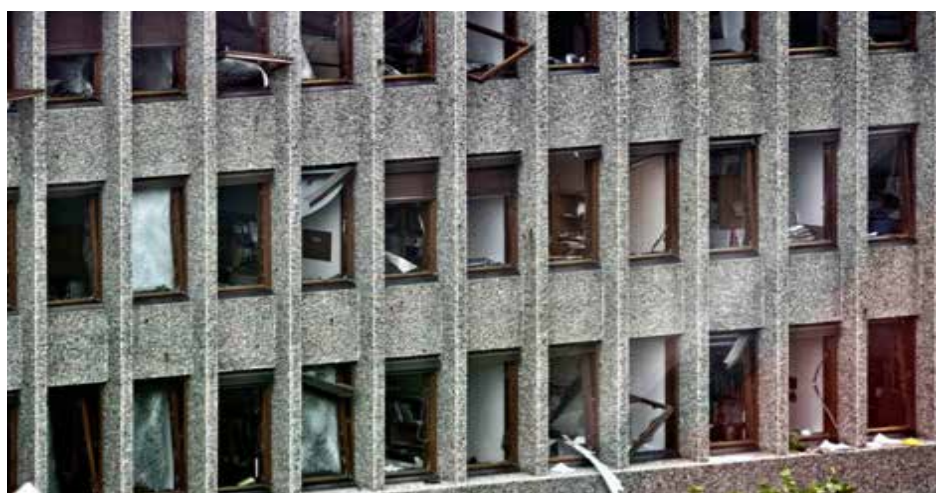
Security film PROFILON® ER1 avoided any life-threatening fragmentation and splintering after the explosion in Oslo.

In the bomb attack in the Norwegian Capital the security film PROFILON® E R1 has proved its protective function and reliability. Although there were some window frames completely pressed out of the reveals there was no life-threatening splintering thanks to the security film.

The multiply film laminate with strength of 475µ is installed from the inside to the window pane and is solidly connected to the frame by a special frame fixture. In addition the highly specialized technology of PROFILON® ER1 provides an impact resistance, a protection against fire penetration and it is flame retardant.
